# Manhole Inspection Summary

Manhole # S150\_\_034MH

Insp Date: **3/27/08 1:19 PM**

**Location** Address: **2680 DULANY-LEHMAN**

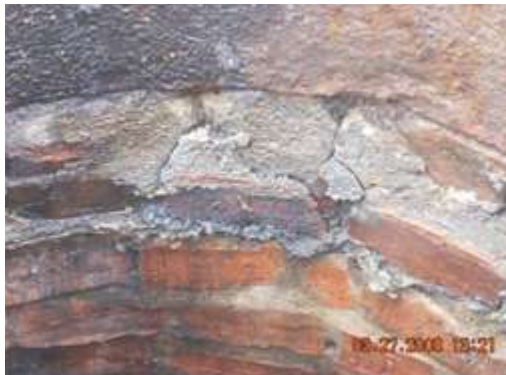
Miscellaneous

Condition: ☐ Sound ☒ **Cracked** ☐ Root Intrusion ☐ Loose Brick ☐ Deteriorated

CRACKED CHIMNEY

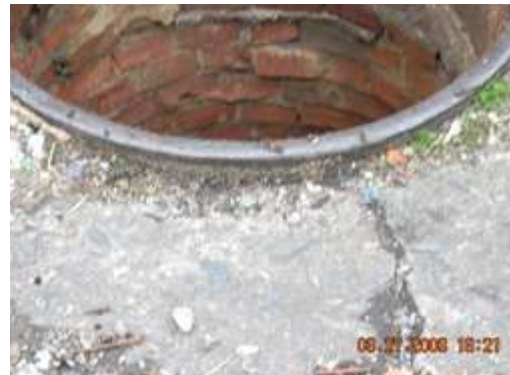
Miscellaneous

**Cover** Shape: **Circular** Diameter: **24** (in.) Length: **0** (in.) Dist A/B Grade: **0.5** (in.)

COVER TO GRADE

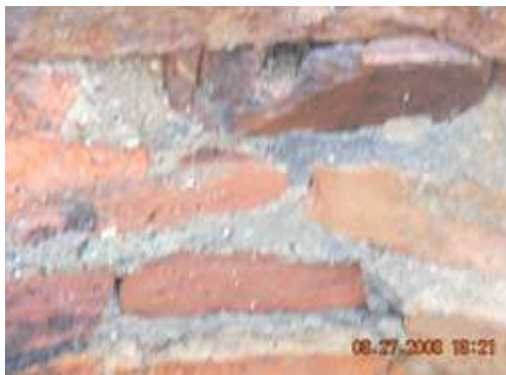
Defect 3

DETERIORATED CHIMNEY

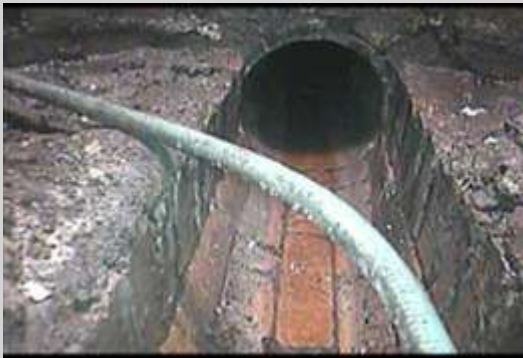
12 O'Clock Outflow

8 in. Circular Gravity Sewer  
Pipe Out @ 12 O'Clock

Pipe Height: **8.4** (in.) Rod and Bar (Angled)  
Pipe Material: **Clay** ☐ Pipe Lined  
Invert Depth: **8.65** (ft.) Flow Characteristics: **Slow**  
Deposits: ☒ None ☐ Mud ☐ Sludge ☐ Debris ☐ Grease  
Silt Depth: **0** (in.) Deposits Extent:  
Infiltration: **None** Pipe Seal Cond: **Sound**

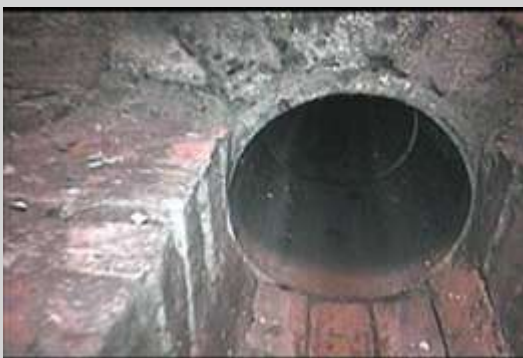
6 O'Clock Inflow

8 in. Circular Gravity Sewer  
Pipe In @ 6 O'Clock

Pipe Height: **8.4** (in.) Rod and Bar (Angled)  
Pipe Material: **Clay** ☐ Pipe Lined  
Invert Depth: **8.59** (ft.) Flow Characteristics: **Slow**  
Deposits: ☒ None ☐ Mud ☐ Sludge ☐ Debris ☐ Grease  
Silt Depth: **0** (in.) Deposits Extent:  
Infiltration: **None** Pipe Seal Cond: **Sound**
